SHORE EROSION STUDY

SHORELINE EROSION AND BLUFF STABILITY ALONG LAKE MICHIGAN

AND LAKE SUPERIOR SHORELINES OF WISCONSIN

KENOSHA COUNTY

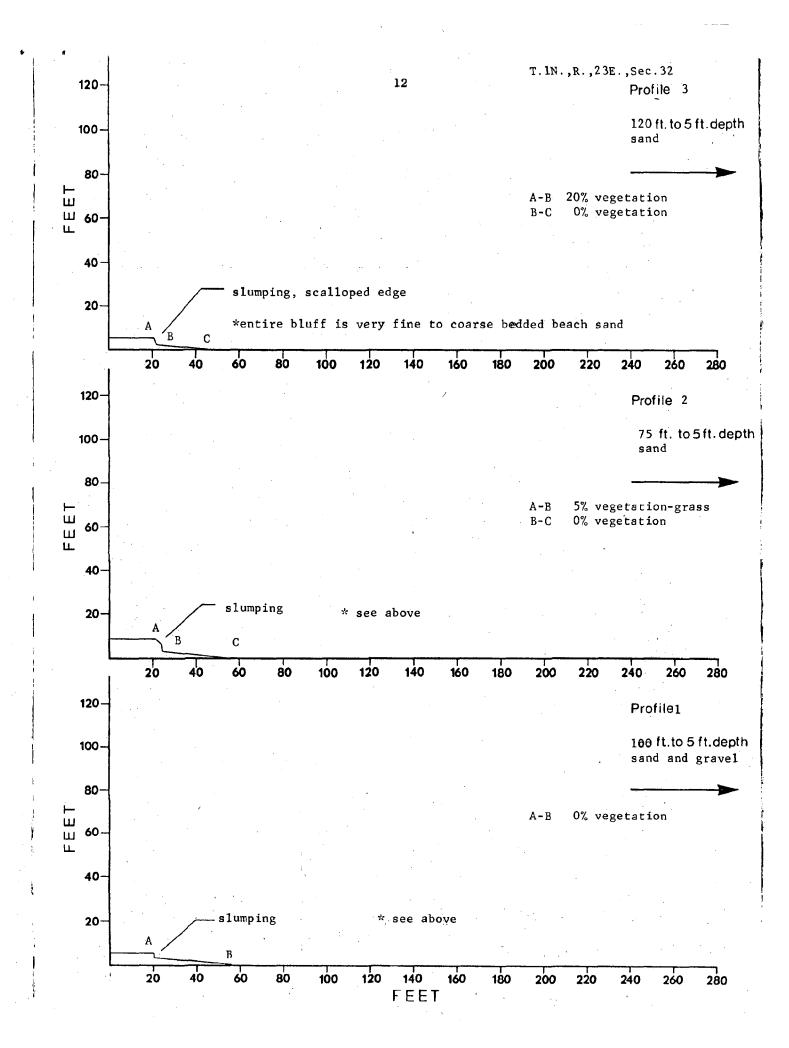
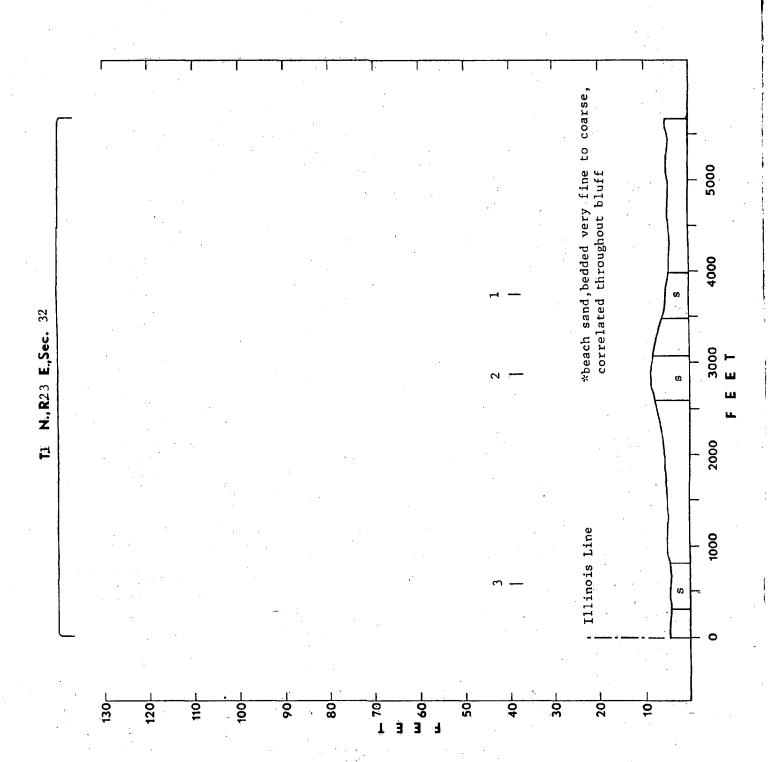
1. BLUFF	a-beach sand, eroding by slump and wave action.	b-beach sand protected by structures	c-beach sand slumping	<pre>d-fairly stable bluff is beach sand protected by structures</pre>
	beach sand -s through wave	and is slumping erosion-swallows holes laterally	in most areas and also weaken blu	, all composed of d also being lost ff by boring ests. Sand is very
2. TOE	a-beach sand	b- beach sand; mostly con- cealed by structures	c-beach sand	
3. веасн	a-less than 5 ft. gravel	b-10 to 20 ft. sand and gravel	c-no beach	d-20 to 35 ft. sand and gravel
	e-20 ft. sand and gravel	f-no beach	g-65 ft. sand and some pebbles	h-no beach
	i-40 to 100 ft. sand and some cobbles	j-40 ft. sand and cobbles	k-no beach; structures present	1-25 to 30 ft. sand and gravel

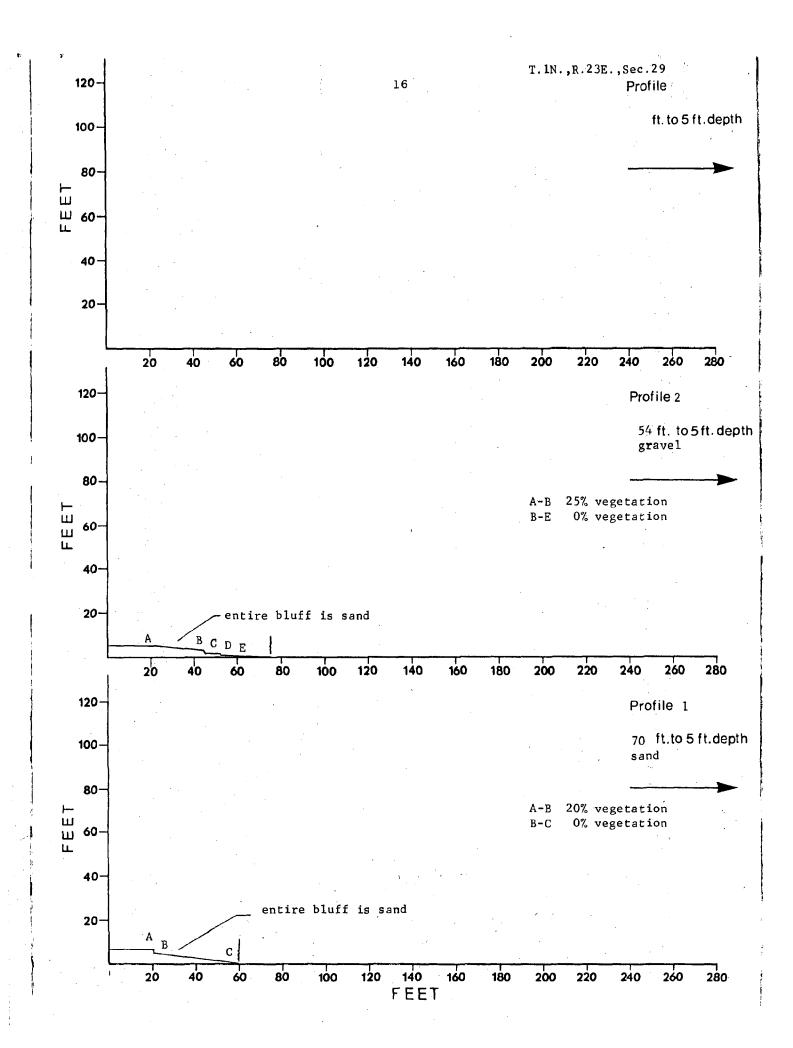
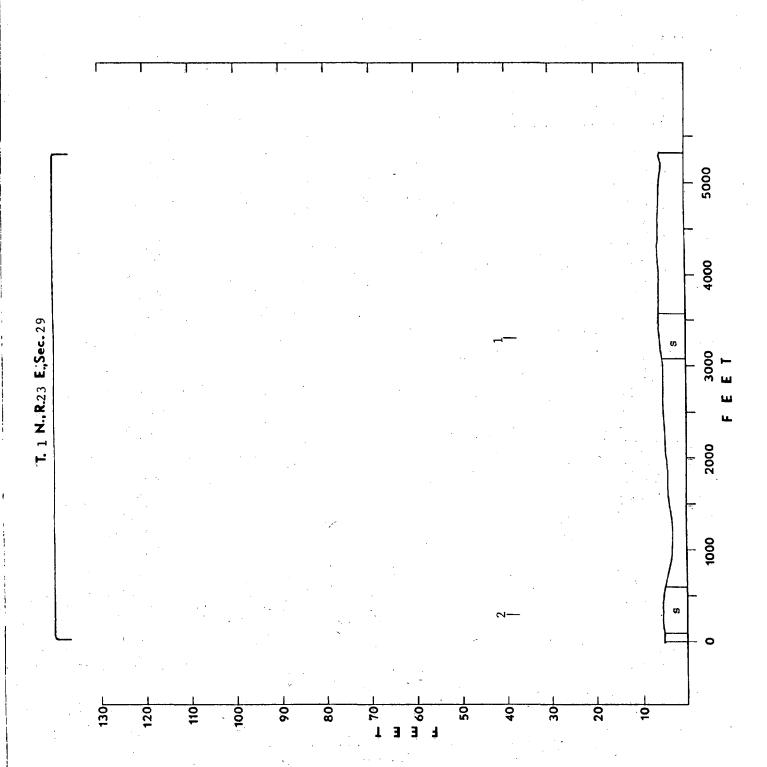
1. BLUFF	a-generally sand, 4 to5 ft. high, failure by slumping and wave erosion where not protected by structures	b-area of slumping and sloughing, bluff edge is scalloped from slumps caused by wave erosion of toe	c-groin field, bluff is fairly stable and vegetated sand	d-sand, 5 ft. high failure by slump; scalloped edge where not protected by structures

2. TOE		is sand, generall xcept where conce		
3. BEACH	a-no béach	b-30 to 40 ft. sand and cobbles	c-5 to 10 ft. sand and some gravel	d-no beach
	e-less than 5 ft. sand	f-no beach	g-10 ft. sand and gravel	h-15 ft, sand and gravel
	i-10 to 15 ft. sand	j-no beach all structures some small beach areas of less than 5 ft.	k-50 ft sand, some pebbles	1-no beach
	m-20 ft. sand and gravel	n-less than 5 ft. sand	o-50 to 75 ft. sand; some gravel	p-20 to 25 ft. sand and gravel
	q-no beach	r-5 to 10 ft. sand and gravel	s-no beach	t-10 to 15 ft. sand and gravel

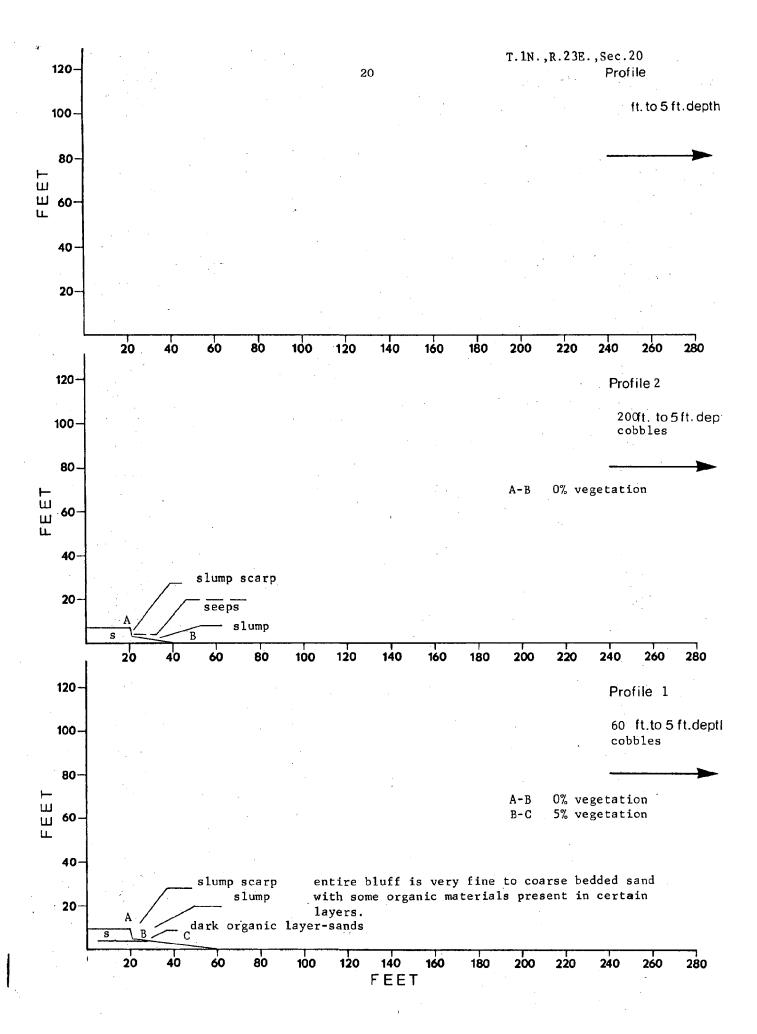
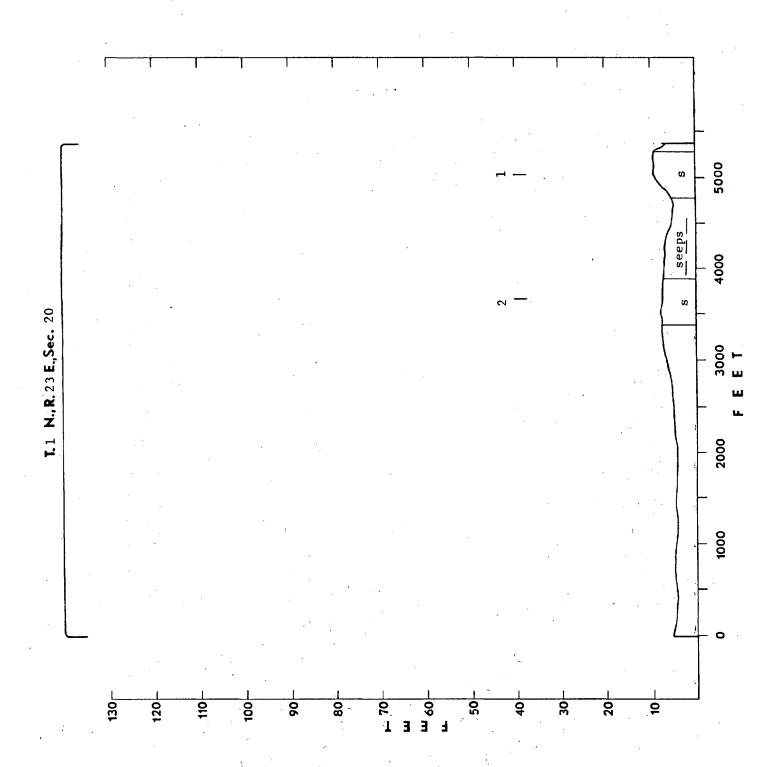
to a strange	we be also a control of the control			
1. BLUFF	a-minor slumping; sand	b-fairly stable protected with structures, well vegetated	bluff edge	d-fairly stable
	e-scalloped bluff edge slumping sand seep zones in lower part of profile 3	f-slumping sand	g-bluff fairly stable;long beaches fairly well vegetated	h-mostly concealed some sand visible, fairly stable with structures
	i-sand;slumping	j-concealed	k-sand,slumping scalloped bluff edge	l-concealed with dolomite structures
	m-sand, scalloped bluff edge; slumps	n-sand+ 20 ft. slumping

2. TOE	a-concealed by vegetation and structures	b-sand, slumping or in place, fine to medium bedded beach sand	c-concealed, lawns, struc- tures	d-sand, fine to coarse layered, beach,slumped or in place
	e-concealed	f-sand, layered, beach	g-concealed, structures, vegetation and fill	h-sand
	i-concealed; structures, some fill	j-concealed, sand	k-sand,slump or in place

3. BEACH	a-no beach	b-15 to 20 ft. sand and gravel	c-20 to 30 ft. sand;some gravel	d-5 to 10 ft. sand and gravel
	e-25 to 35 ft. sand and gravel	f-less than 40 ft. sand and gravel	g-no beach	h-less than 30 ft. sand and gravel, narrows toward south to 10 ft.
	i-no beach	j-40 ft. sand and gravel	k-no beach	1-40 to 50 ft. primarily sand; some gravel

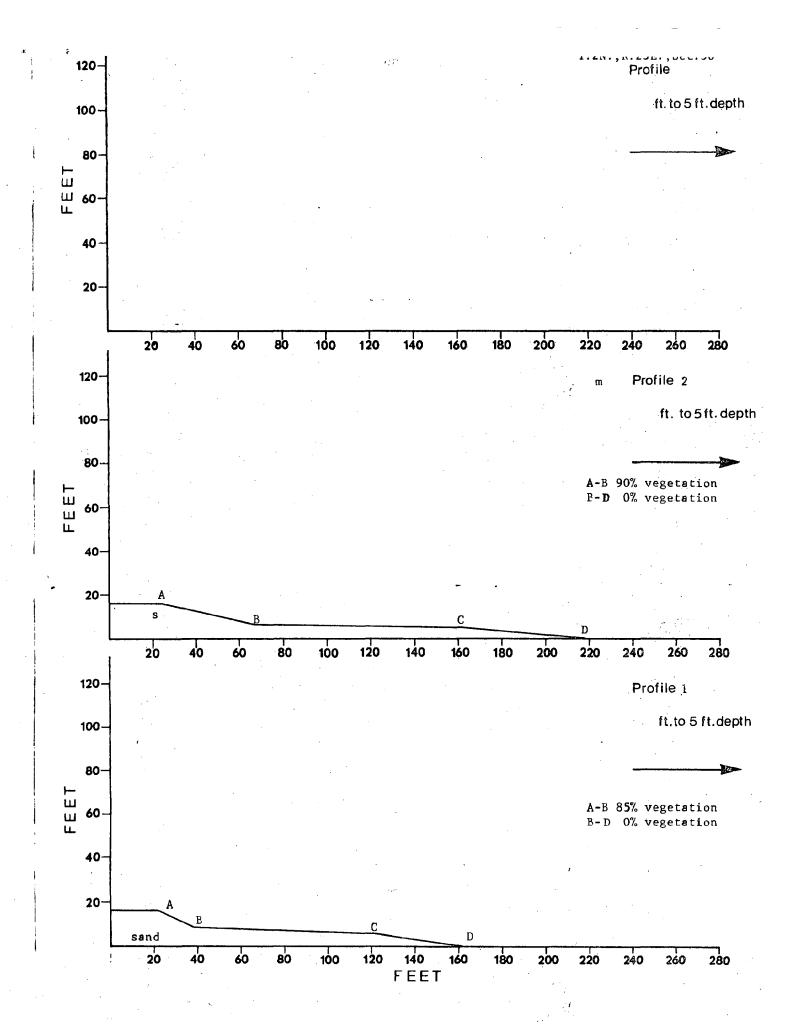
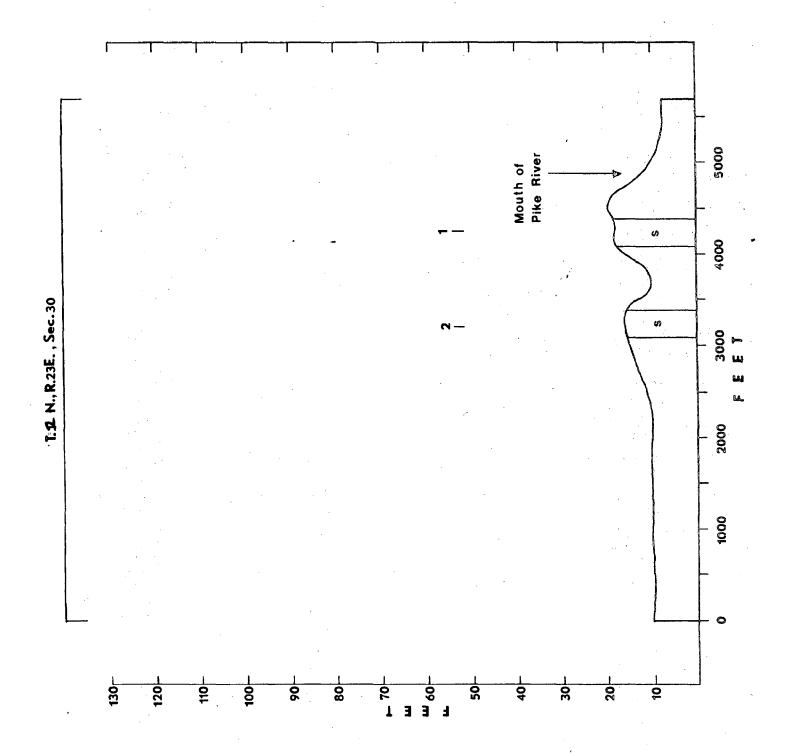
1.BLUFF	<pre>a-no bluff gentle slope upward</pre>	b-grassed; reasonably stable	c-no bluff	d-stable; well vegetated, materials concealed	e-slump area,bluff partially graded
	f-relatively stable in most places; vegetated, bluff partially graded	g-no bluff; graded slope for building			
2. TOE	a-no bluff	b-sand	c-no bluff	d-sand and coarse silt	e-mostly covered
	f-pinkish brown lacustrine clay	g-concealed			
3. BEACH	a-275 ft. sand and some gravel	b-188 ft. sand, some gravel	c-194 ft. sand, some grave	d-151 ft. sand and gravel	e-140 ft. sand and some gravel
	f-110 ft. sand and some gravel	g-20-100 ft. sand and gravel	h-no beach; beach concealed by new dolomite revetment now under construction	·

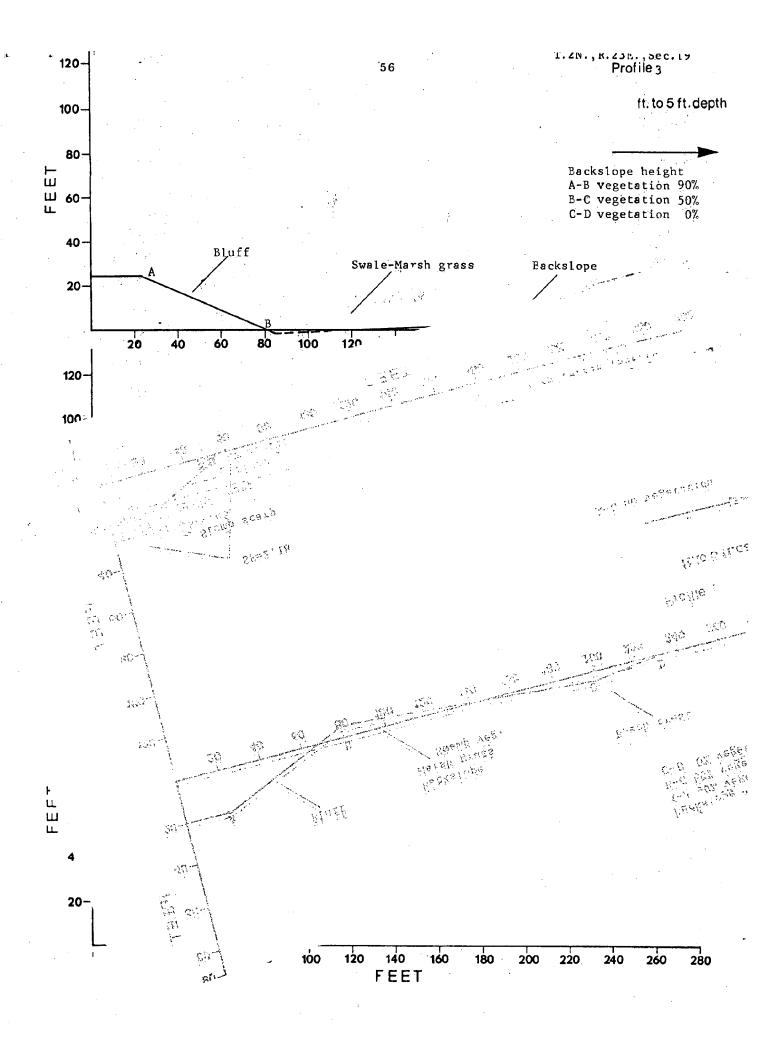
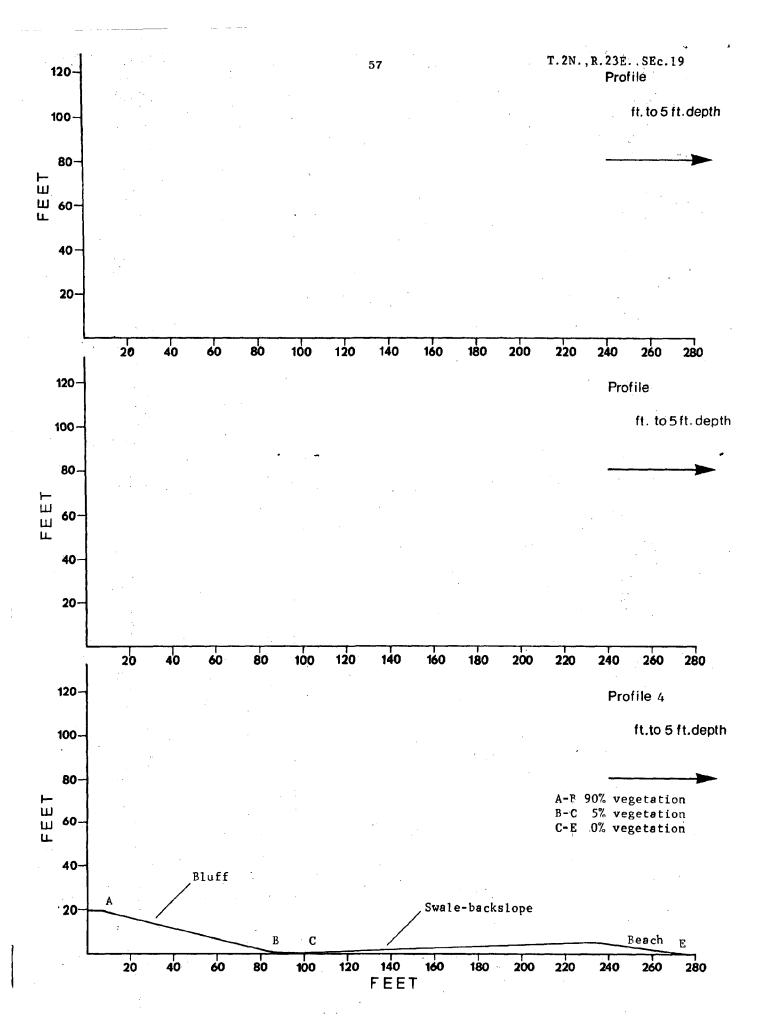
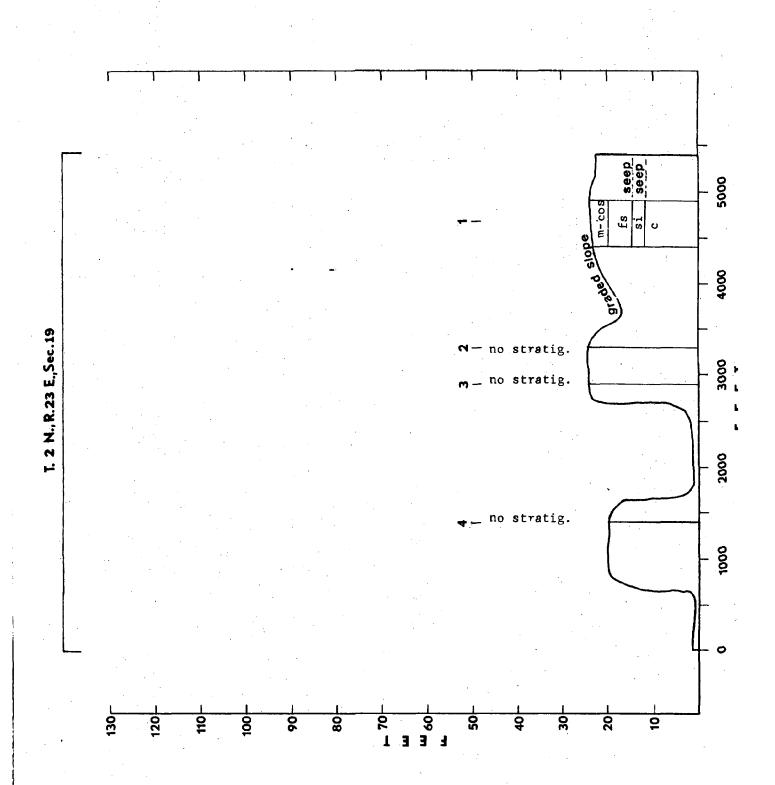
1.BLUFF	a-scalloped bluff edge, lacustrine silt-many places concealed with fill and debris,slump blocks along here in many places	b-mostly con- cealed, some slump areas in lacustrine silts	c-slumping in lacus- trine silts	d-fairly stable grassed area
	e-scalloped bluff edge bluff here 25- 30 ft. high- planar and rotational slump blocks in lacustrine silts	d-lacustrine silts with sand on top (2 ft.), slumping- scalloped bluff edge		
2. TOE	a-either con- cealed or lacustrine sediments in place or slumped	b-concealed	c-lacustrine silts mostly in place some slumped	
3. BEACH	a-less than 5 ft., cobbles	b-no bea c h	c-10 to 15 ft. sand and gravel	d-no beach
	e-less than 20 ft.,sand and gravel less than 40 ft. in places and 25 to 30 ft. in others.	f-0 to 5 ft. sand and gravel mostly gravel and cobbles toward south end of area

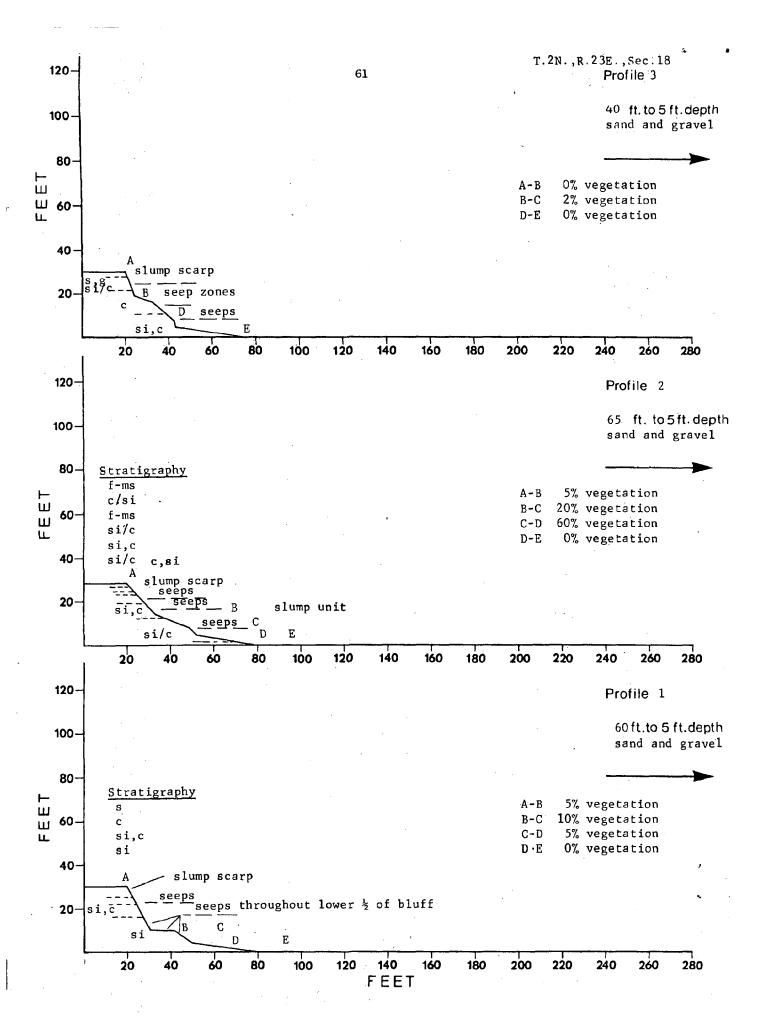
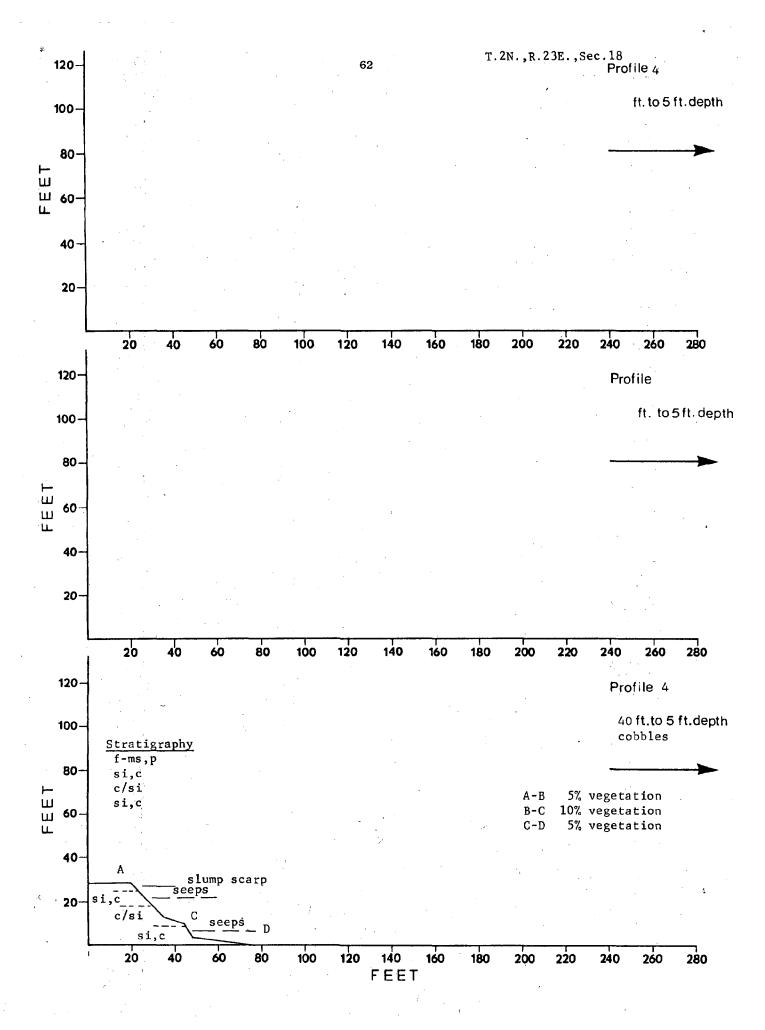
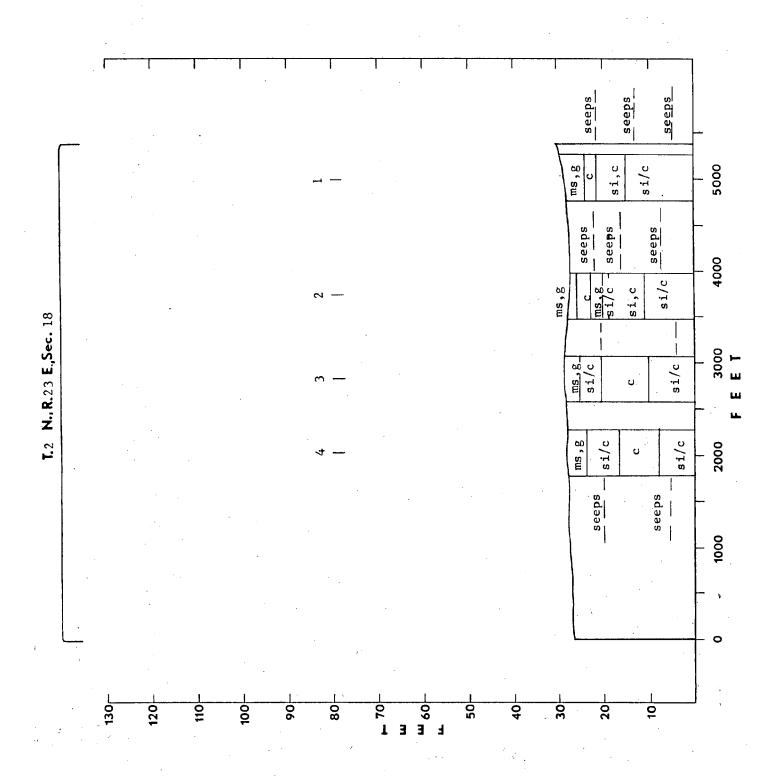
1	,	
1. BLUFF	<pre>a-concealed fill piled on slopes</pre>	b-some toe erosion, but considerable vegetation- much fill	c-fill; slumped	d-till at toe bluff failing by slump and toe erosion	concrete, debris, some
	f-slumping; lacustrine sediments, planar slump,sand at top of bluff	g-fairly stable; vegetated	h-planar slump- previously graded	<pre>i-graded; eroding from runoff</pre>	j-lacustrine silt and clay slump area, blutt scalloped, seep zones in silt
	k-lacustrine silts with seep zones; bluff scalloped, slumps	<pre>l-bluff slumpi in places; dangerous materials piled on slope</pre>	ng

3. BEACH	a-10-15 ft. sand and gravel	b- 5-10 ft. sand and gravel	c20 ft. sand and gravel	d-5-10 ft. sand and gravel	e5 ft. sand and gravel
	f20 ft. sand and gravel	g-no beach	h20 ft. sand and gravel, some small areas -10 ft.	i-5-10 ft. sand and gravel	j20 ft. sand and gravel
,	k-5-10 ft. sand and gravel	l20 ft. sand and gravel	m-no beach	n20 ft. sand and gravel	o- no beach
	p- +20 ft. sand and gravel	q- no beach

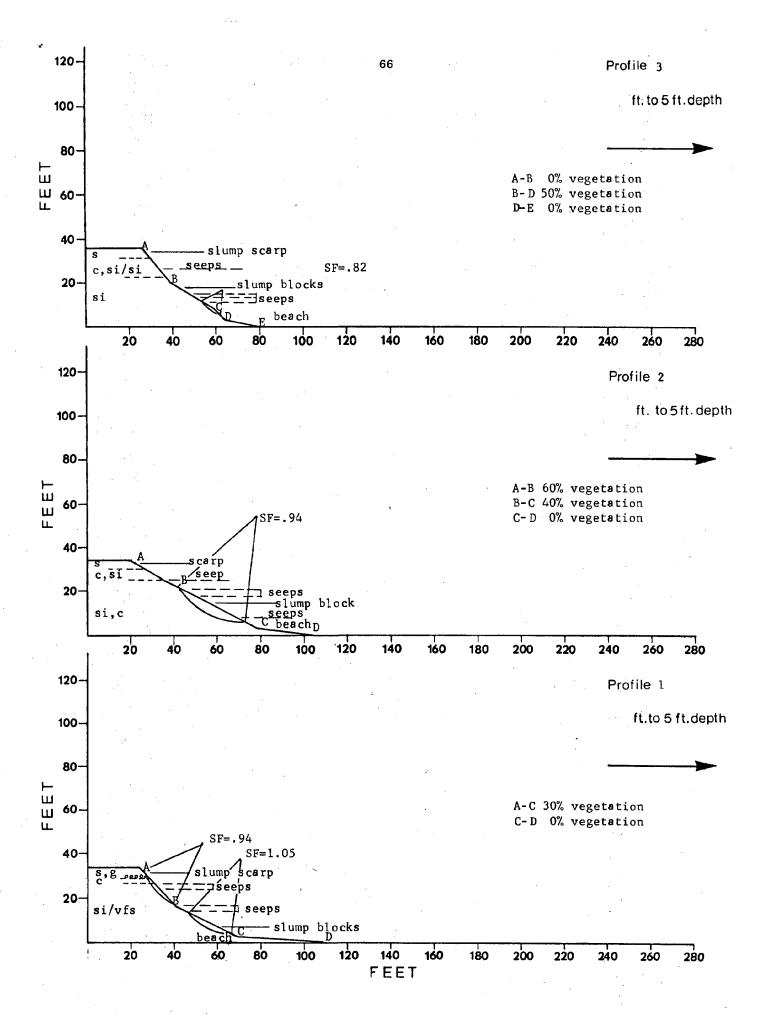
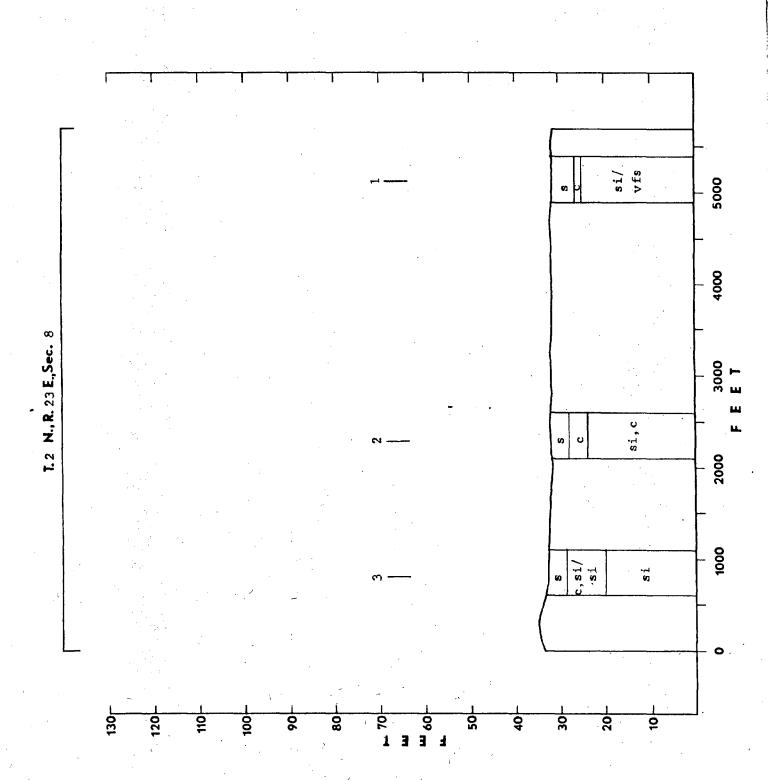
1. BLUFF b-fairly d-slope piled e-graded bluff a-severe c-severe rotational stable; with debris; rotational and planar vegetated, slump, wave failing by slump- toe lawns, etc. erosion s1ump erosion (waves) and slides and flows, scalloped bluff edge f-moderate g-relatively stable, to severe planar vegetated slump and terraced 2. TOE b-unobservable; c-till, in d-mostly a-till e-till overlain by lawns, etc. place, some unobservable; lacustrine slump also where visible, toe sediment, is till some slump, some in place f-unobservable; g-till, in stuctures place and graded lawns 3. BEACH a- -5 ft. b-0-5 ft. c-20-40 ft. d-15-20 ft. e-5-15 ft. sand and sand and sand and cobbles and gravel gravel gravel gravel gravel g-10-15 ft. h-no beach f- -5 ft. pebbles cobbles, and gravel gravel, mostly no

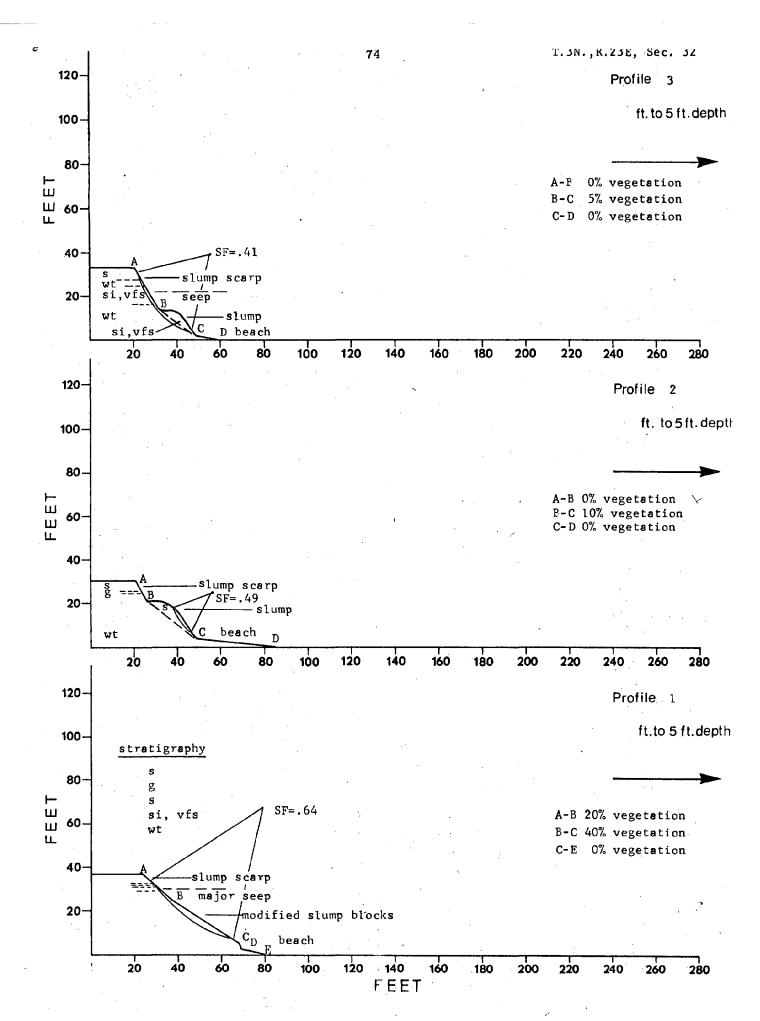
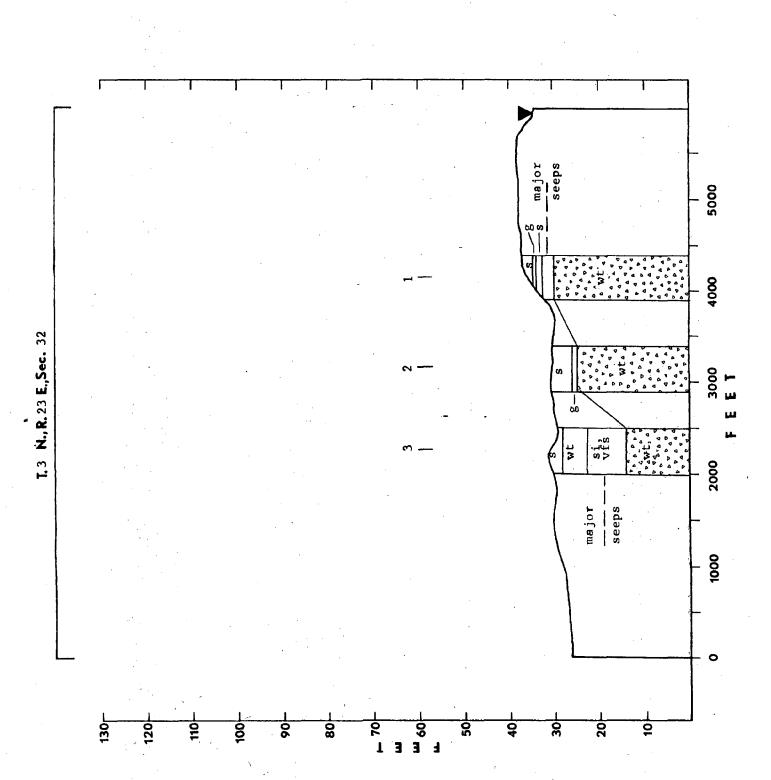
1. BLUFF	a-failure by slump	b-bluff consists of recent artificial fill	c-serious slope failure caused by slump, debris flow; also by the erosion, surface water coming over top of bluff, water issuing from seep zones in silt and sands above till. Foundations undercut and exposed. Scalloped bluff margin, slump scarps at top of bluff.

2. TOE	a-natural toe material is till, covered in most places by slump or artificial fill debris.	b-toe material consists mostly of artificial fill and debris dumped over top of bluff (broken concrete,slag, iron,bicycles, kitchen sinks)	c-dolomite blocks (revetment), with till behind	d-natural toe material is clayey till, till covered in many places by slag (at northern end), broken concrete, dolomite blocks and various types of debris
	e-dolomite blocks (revetment)	f-sheet-steel piling (bulkhead)

3. BEACH	a-0 to 5 ft., cobbles and pebbles	b-5 to 10 ft., pebbles and cobbles	c-no beach	d-0 to 8 ft., gravel,broken concrete, stone, wood, junk
	e-5 to 10 ft., beach is gravel,slag, bricks,junk and iron	f-no beach less than 5 ft.,slag, pebbles, junk	1
